With this seventh update for the **2021 Fresh Coat Initiative: Post Pandemic Spruce Up**, we highlight the work completed at the Butner Shop (Jail/Watch House & City Hall) building. Although the building is small, we found more wood rot to the cedar clapboard than expected. Careful repair and painting now present the structure beautifully between the private residence Butner House and the newly painted Winkler Bakery.

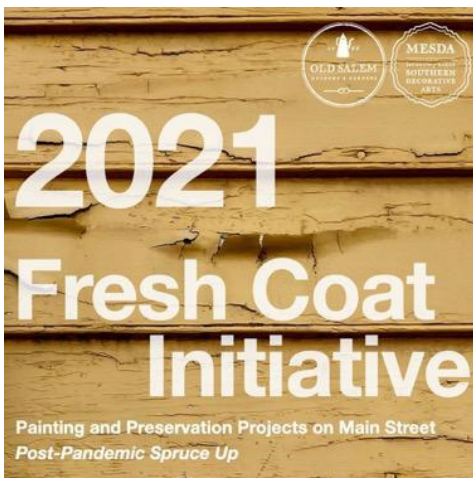
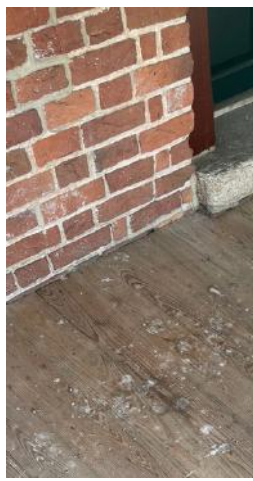
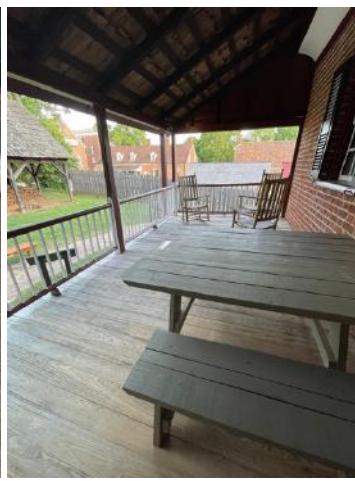
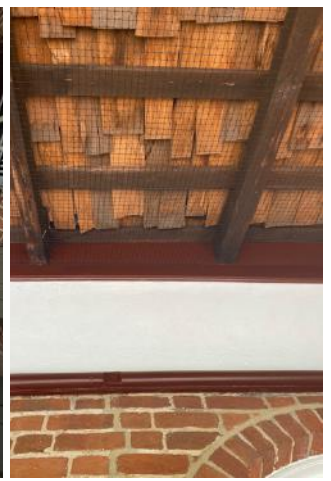
(left to right) The back porch of the historic Winkler Bakery had a problem with bird waste and squirrels nesting in the exposed ceiling & wood shake roof. Preservation netting has been fully installed, and now the entire porch has been power-washed to provide a clean spot to enjoy Winkler treats. **Thank you to our Preservation team for completing this effort.**

The back porch of Winkler Bakery is now ready for visitors with fully installed preservation netting and freshly cleaned porch floor and furniture. If you have a moment, sneak to the back porch, sit on a rocker and enjoy the unique view of Salem Square and Home Church.

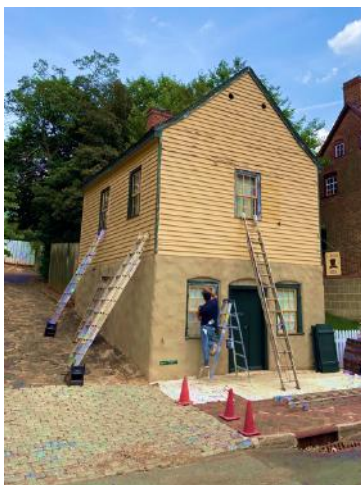
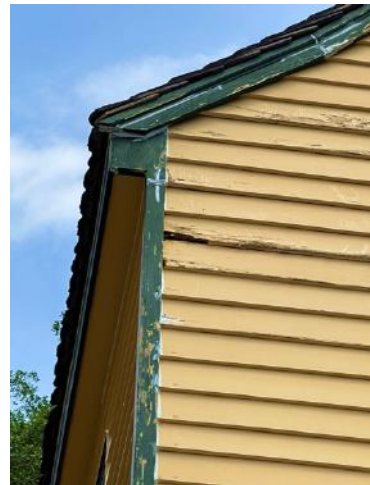
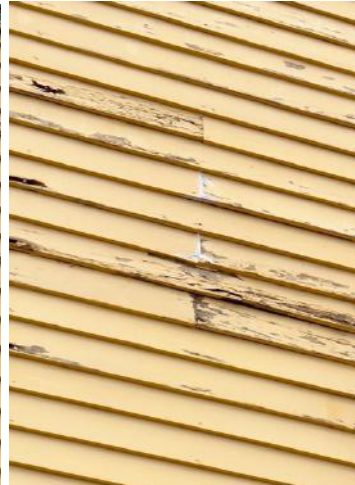
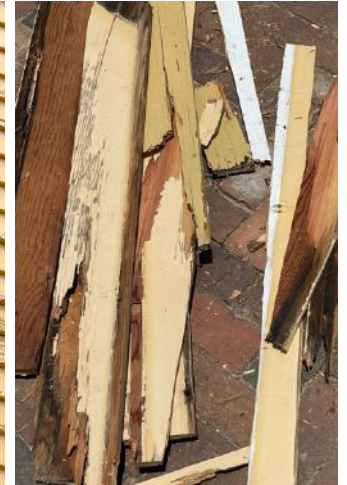
(left to right) The Butner workshop & store building is the latest historic structure to be worked on. Although a small building, the wood repair needed to the exterior clapboard (although cedar) was more extensive than anticipated. Due to selective wood clapboard repair, we paid particular attention to the appearance & location of the visible handmade nails. **Special thank you to Erik Skarzynski, Director of Facilities for project managing.**

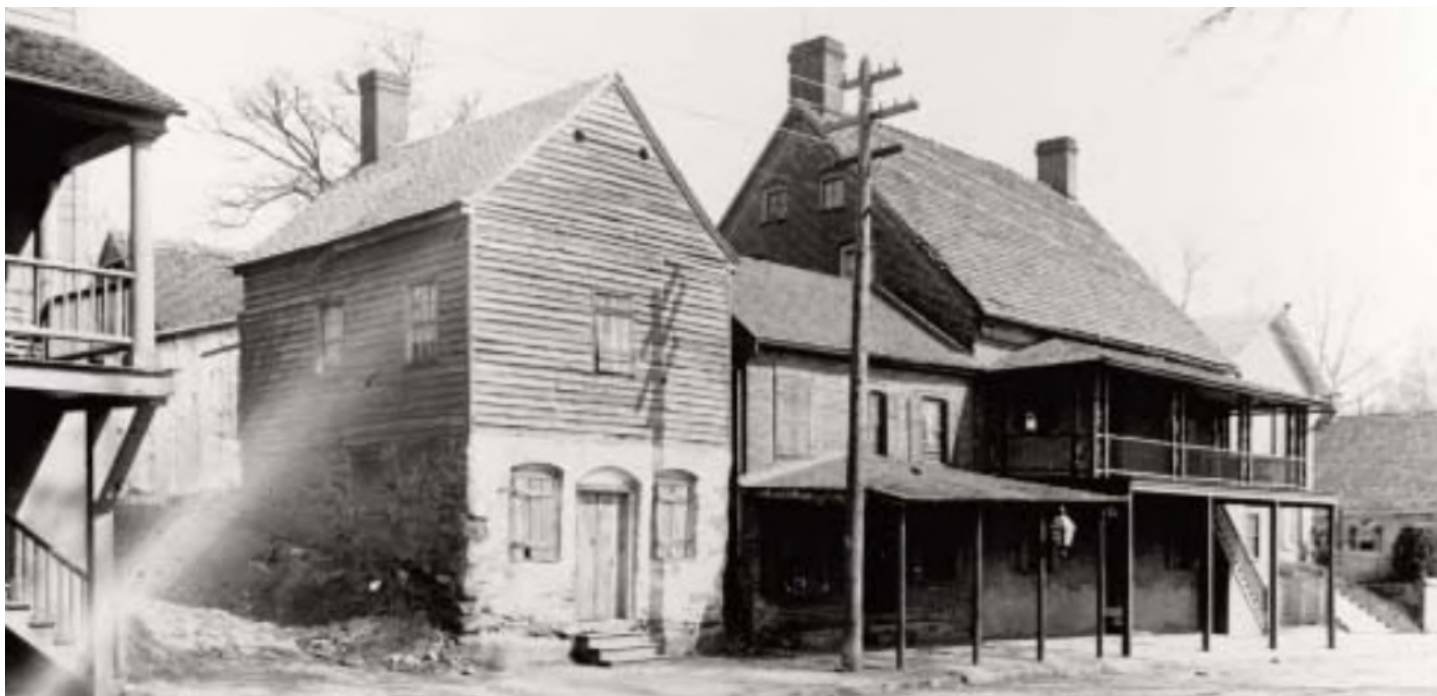
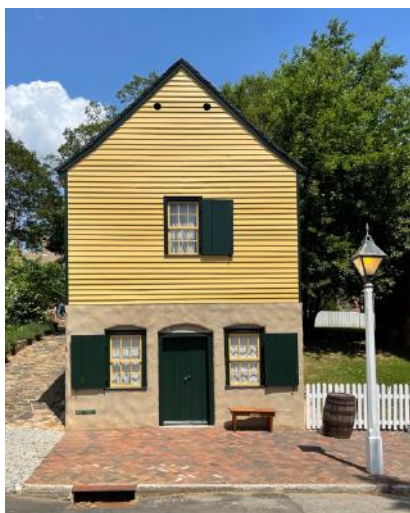
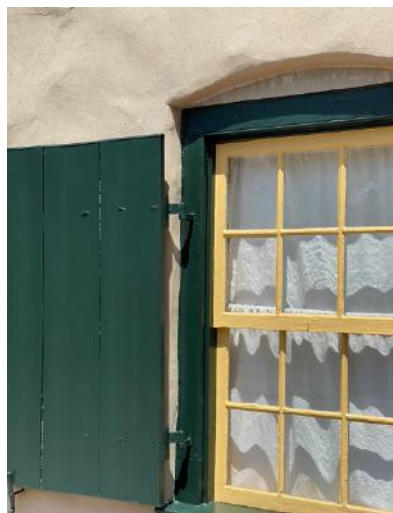
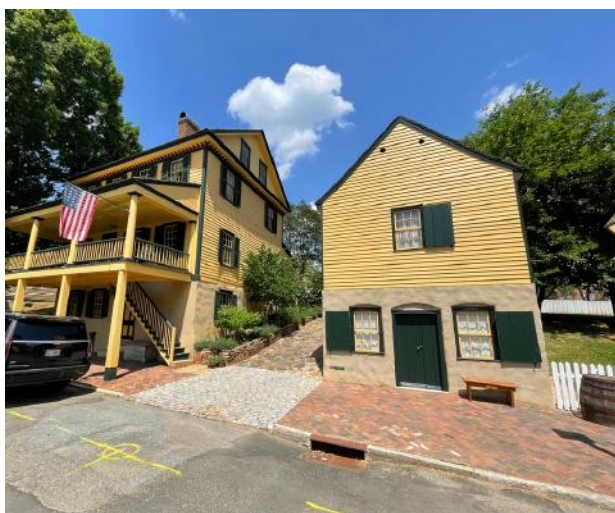
(left to right) Historic photographs show the building perhaps was not painted or only whitewashed; the color of the building now matches the private residence of the Butner House.

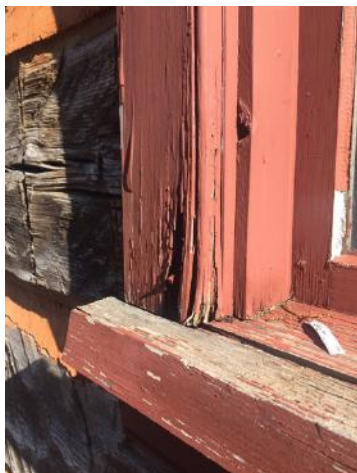
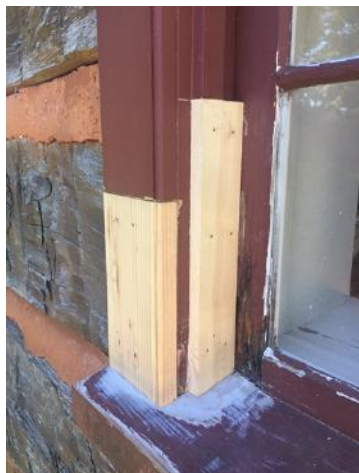
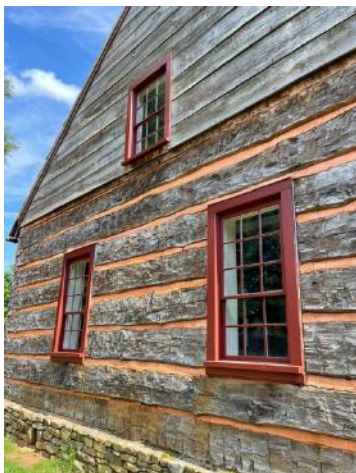
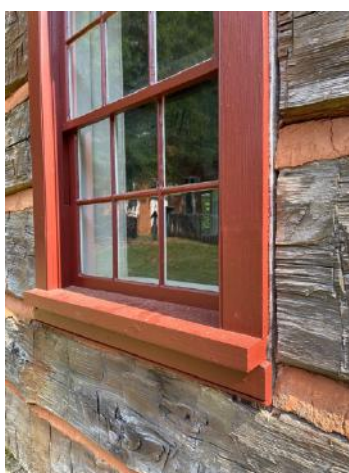
(left to right) Our Fresh Coat Initiative work includes the wood window repair and painting of the St. Phillips Log Church. As a fully reconstructed building, the material selection and replacement involve less restrictive parameters. Just as in the Butner Shop building, the selective wood replacement at the log church requires attention in the appearance of the location and type of nails. We are considering the repair of the “chinking” to become a public-facing preservation workshop. Thank you to Tony Bragg, Facilities Team, for his work on the window repair and painting.
