With this ninth update for the **2021 Fresh Coat Initiative: Post Pandemic Spruce Up**, we are showing highly detailed restoration work hidden in plain sight. In fact, the work has been so expertly performed that most of us would never notice the final results of the preservation efforts. Except for some logistical assistance, much of this work has been managed and completed by our own joiner and **craftsman Ben Masterson with the assistance of craftsman Blake Stevenson**.

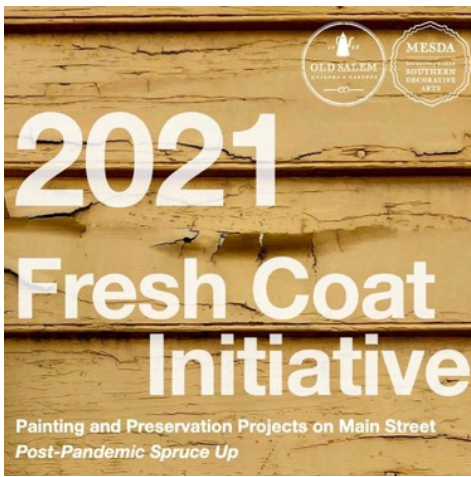
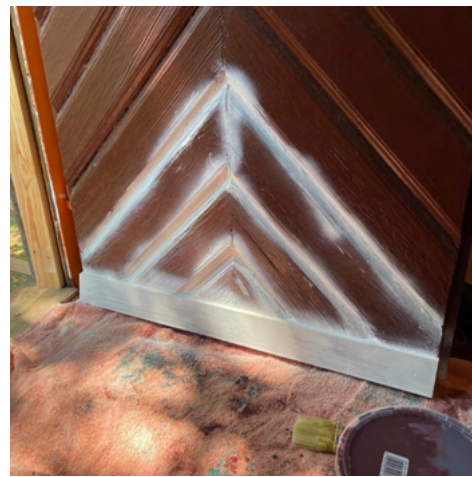
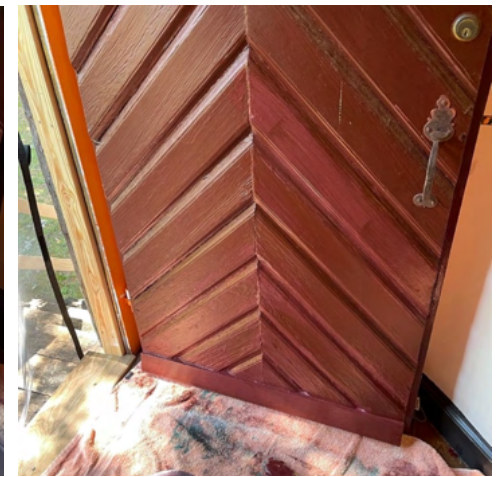
*(Left to right) The decay of historic material is a constant concern for preservationists. Things that seem minor, such as weathering on the exposed western-facing exterior door at the Fourth House, can result in hidden dramatic effects from water infiltration. Shown in these photographs is the repair and repainting of the reproduction door. One of the projects facilitated by our joiner **Ben Masterson**.*

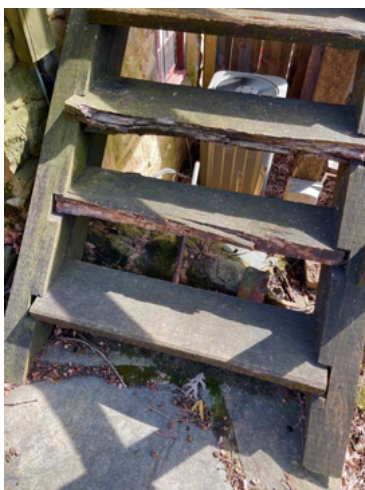
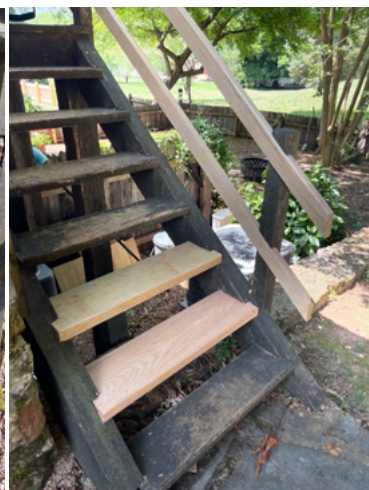
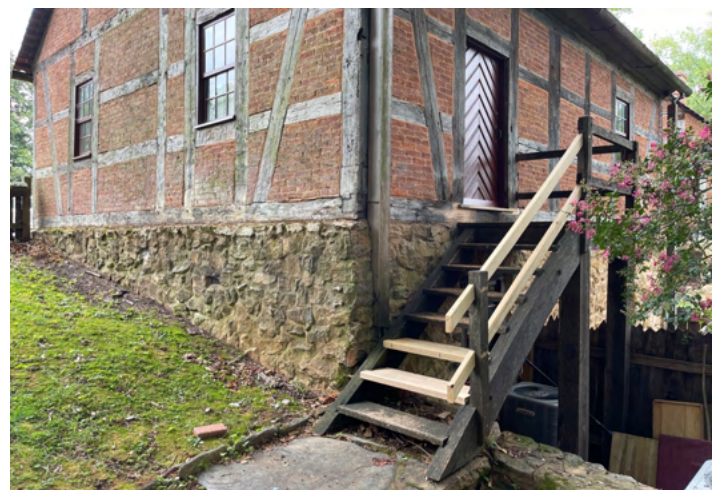
*(Left to right) The exterior back stair treads and railing at the Fourth House were unsafe. The Fourth House is the location of large fundraising & celebratory gatherings orchestrated by the President's Office. The first gathering post-pandemic will take place as an opening for the Museum of Early Southern Decorative Arts "Map Seminar" in September 2021. This work was primarily facilitated by joiner **Ben Masterson**.*

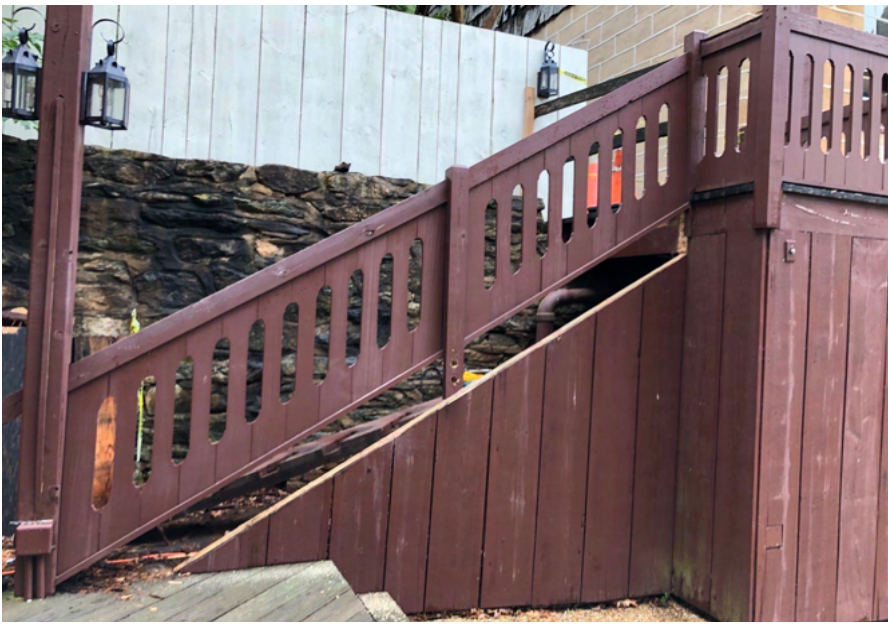
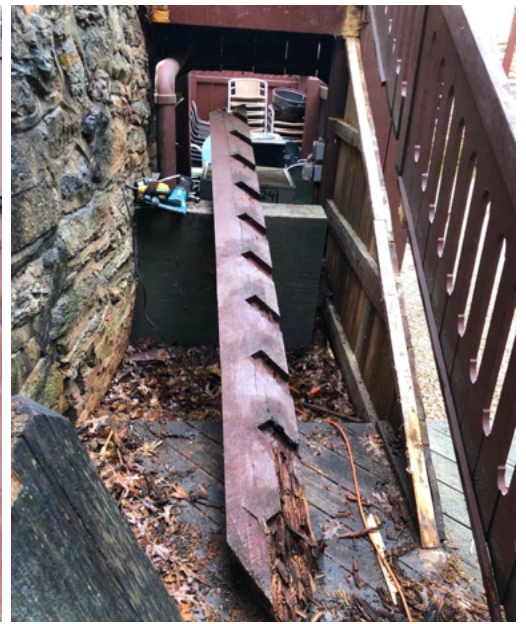
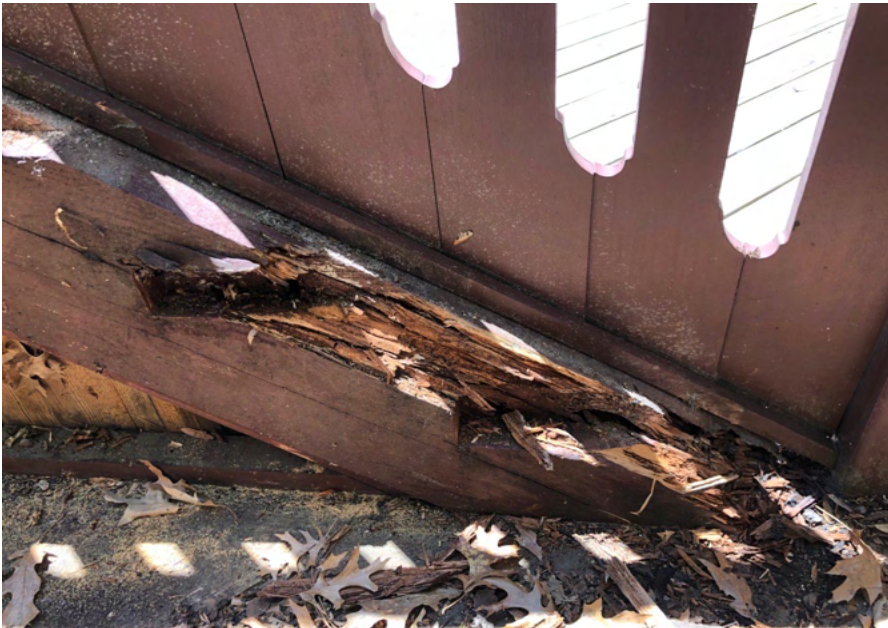
(Left to right) The public stair that runs from Main Street down to the plaza in front of Salem Stitches and Muddy Creek Café had been closed due to rot (a public safety hazard). In preparation for our Phase Two Reopening, we have restored the stair based on its original design. This stair is particularly important as Muddy Creek Café and Salem Stitches will be reopening in Phase Two. This restoration work was primarily completed by **craftsmen Ben Masterson**, with the logistical assistance of **Blake Stevenson, craftsman, Erik Skarzynski, Director of Facilities, and Tony Bragg, Facilities Associate**

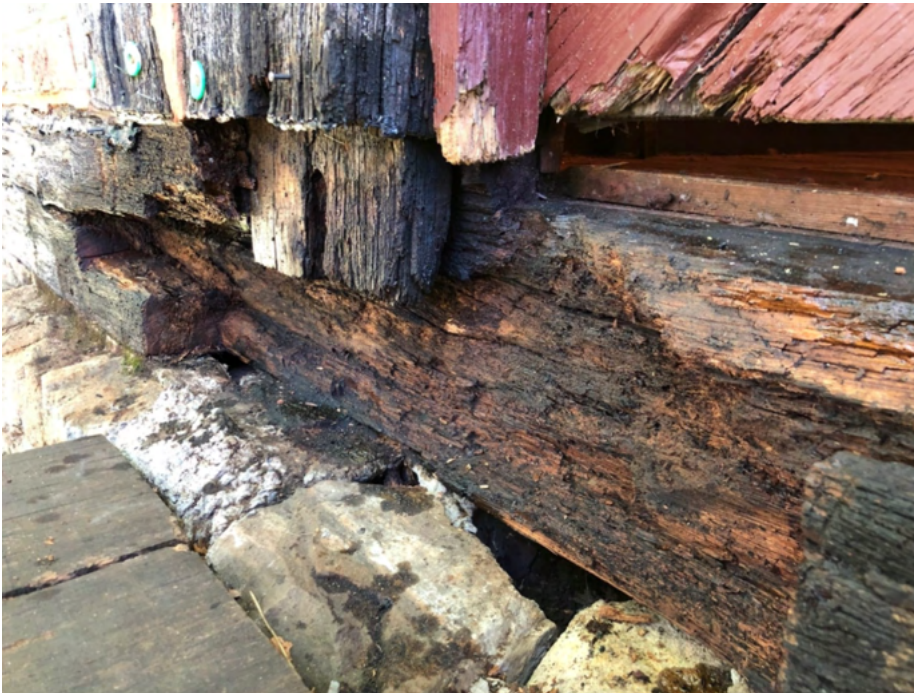
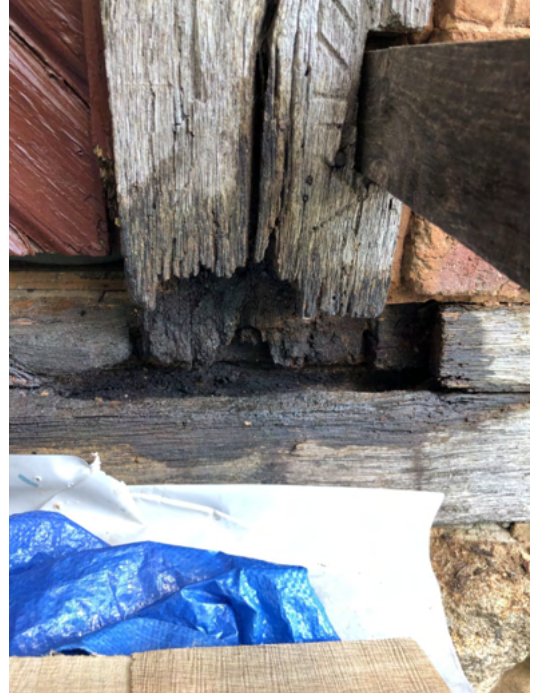
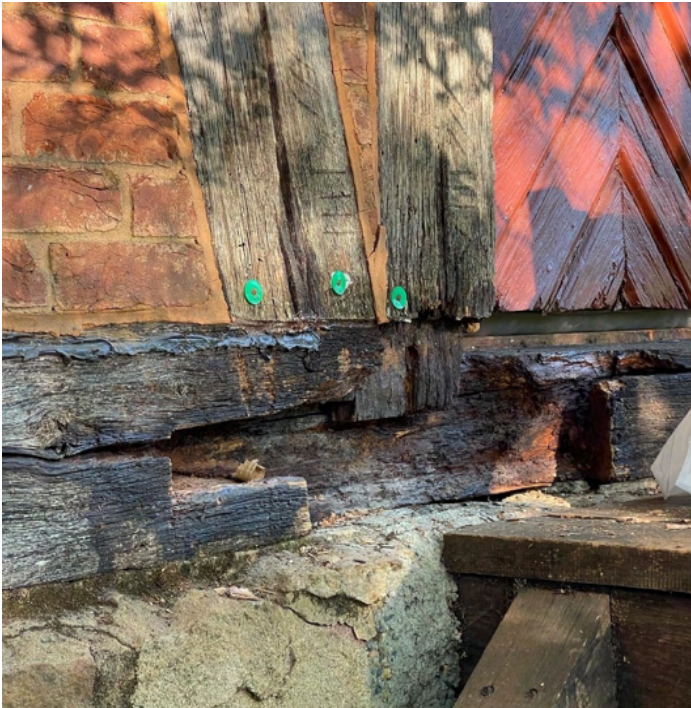
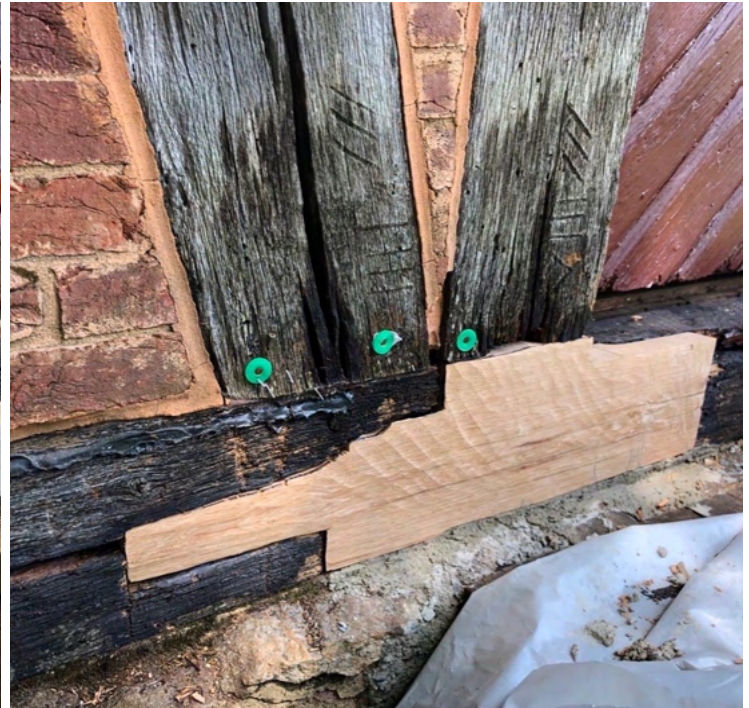
*(Left to right) The orthwestern corner of the Fourth House was in need of considerable repair. Due to poor water drainage at the rear stair, an entire wood joint had rotted away from the sill timber. . . A dutchman repair was utilized to seamlessly patch the compromised joint. The handrail had also dislodged from the building and was failing. Each step of the restoration can be seen in these photographs. The final restoration is pictured below. This repair was primarily completed by joiner **Ben Masterson** with assistance from craftsman **Blake Stevenson** and the logistical assistance of **Erik Skarzynski**, Director of Facilities and **Tony Bragg**, Facilities Associate.*
