With this tenth update for the 2021 Fresh Coat Initiative: Post Pandemic Spruce Up, we have completed our repair and repainting of the historic Blum House. Donated to Old Salem in 1985, this important building on Main Street was historically utilized as the first bank in the town of Salem and one of the first printing presses in the state of North Carolina. Today, the Blum House is home to the Joinery and Woodcrafts shop where visitors can experience hands-on, traditional woodworking. So far, the Fresh Coat Initiative has completed 45 distinct projects located in 16 historic district locations and the Blum House is a wonderful addition to these important preservation projects on Main Street.

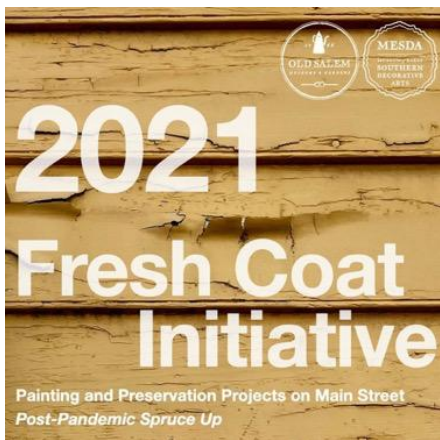
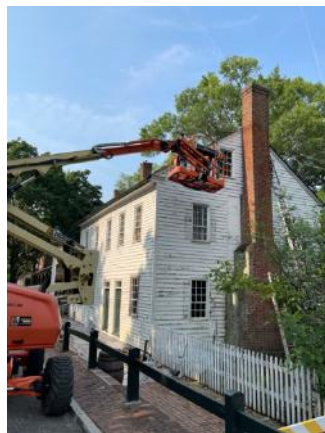
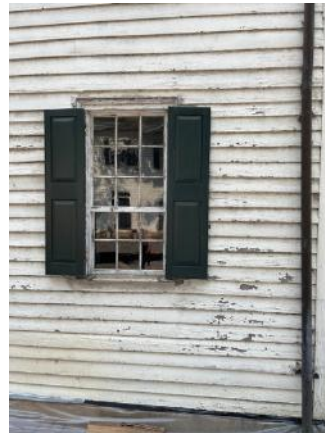
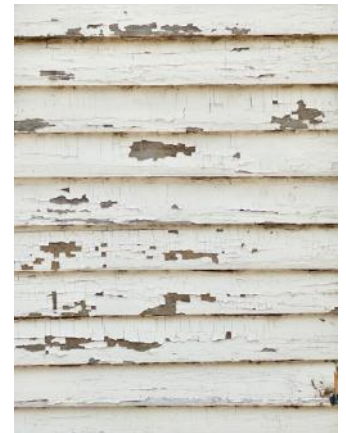
*(Left to right) The Blum House, a basic white wood box, looks deceptively simple. The restoration work to the Blum House involved several layers of delicate restoration work; 1. Wood rot and repair to various elements (eaves, shutters, window sashes), 2. Exterior scrapping, priming, and painting, 3. And patching several roof leaks. The final result (photograph below) brings the house and attached print shop back to a crisp white painted finish with operable shutters.*

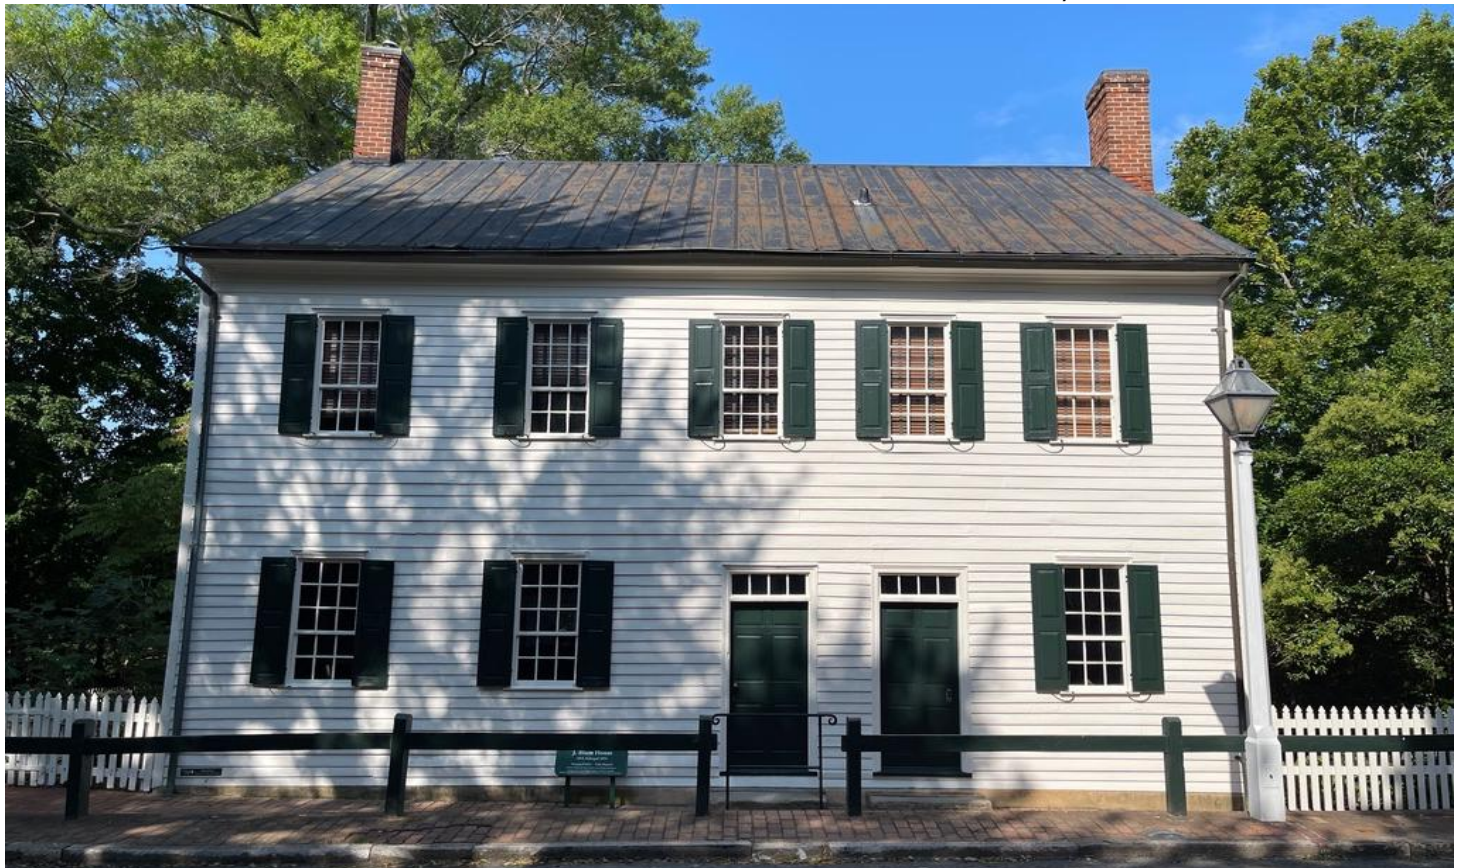
*(Left to right) The exterior condition of the Blum House had significantly deteriorated. Because of its massing, a lift was needed to prepare and repair building fabric on the upper levels of the house. The first step in preparing the home for repairs was to delicately wash the house and chimney. Care was taken to follow preservation best practices to avoid infiltrating wood siding or introducing moisture to the historic bricks which could cause spalling.*

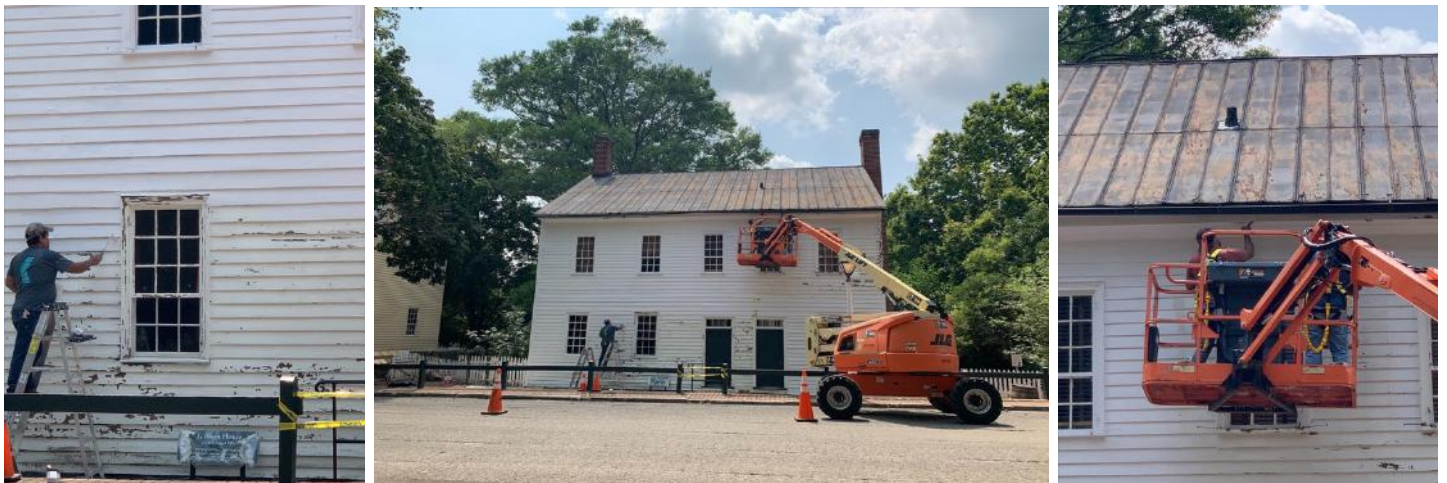
*(Left to right) The preparation process for the exterior repainting of the Blum House was involved. First, careful placement of plastic tarps around the building allowed us to capture debris. Next, the thorough, careful cleaning of the entire exterior revealed areas where wood repair was needed. After the necessary wood repair, our wonderful painters carefully scrapped and primed the exterior and applied several coats of fresh paint.*

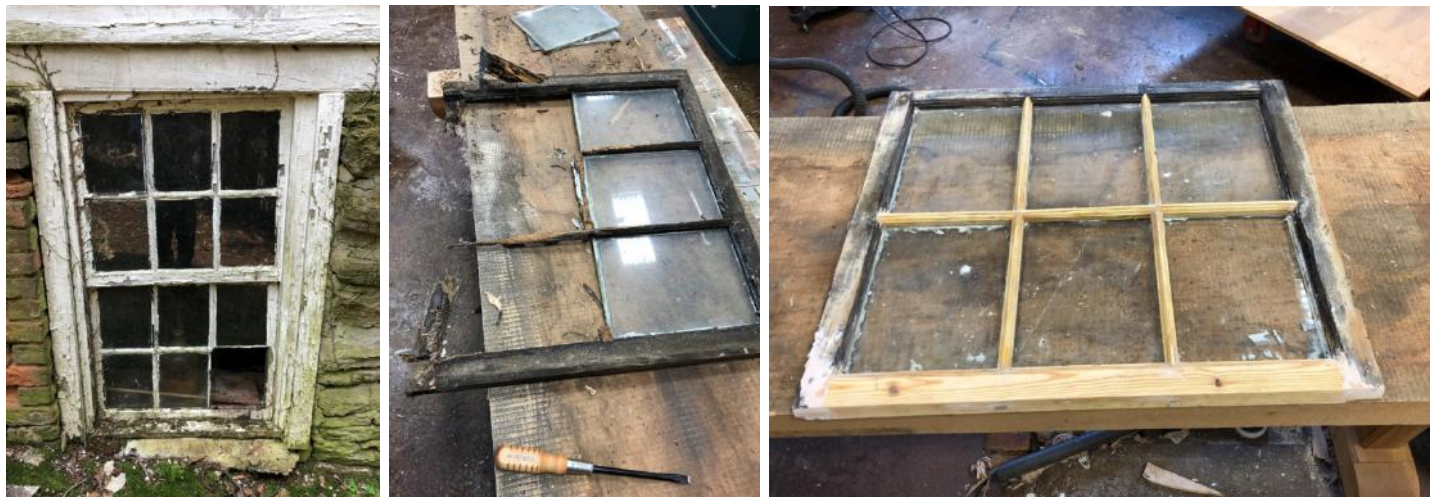
*(Left to right) Before any repainting could occur, we had to assess the restoration needs of various building parts. Shown above is the condition of one of the basement windows that needed extensive repair and restoration. The restoration of the wood sash was primarily completed by joiner **Ben Masterson** with the logistical assistance of **Erik Skarzynski**, Director of Facilities.*

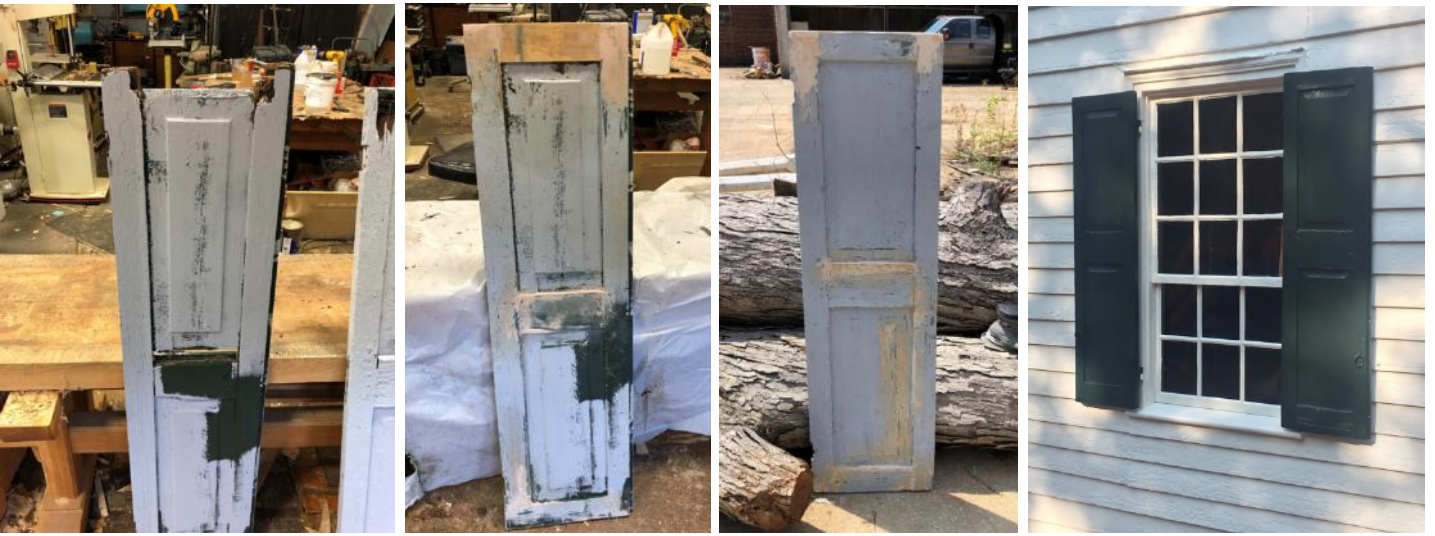
*(Left to right) After removing the shutters, careful evaluation of the condition suggested repairs that were needed. The shutter repairs were primarily completed by joiner Ben Masterson with the logistical assistance of Erik Skarzynski, Director of Facilities, and Tony Bragg, Facilities Associate.*
