With this eleventh update for the 2021 Fresh Coat Initiative: Post Pandemic Spruce Up, I present to you the complexity of restoration details that must be resolved before we can even put the first brush to paint. The Herbst House (location of our new SEED SAVING LAB) is our current active project. It has been several decades since the Herbst House was renovated, and the repairs to the exterior wood sheathing are extensive. Phase One of the Herbst House consists of resolving the most acute Main Street facade repairs and then painting the street-facing elevation and porch. Phase Two of Herbst repairs will occur following completion of our 2021 Fresh Coat Initiative priorities.

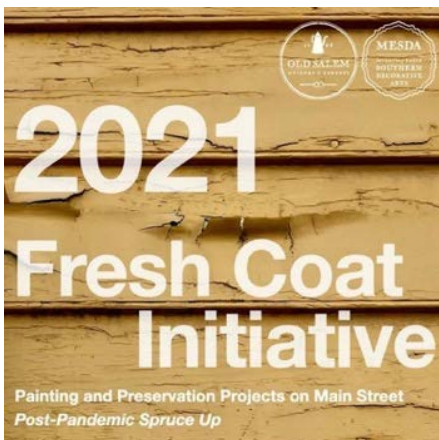
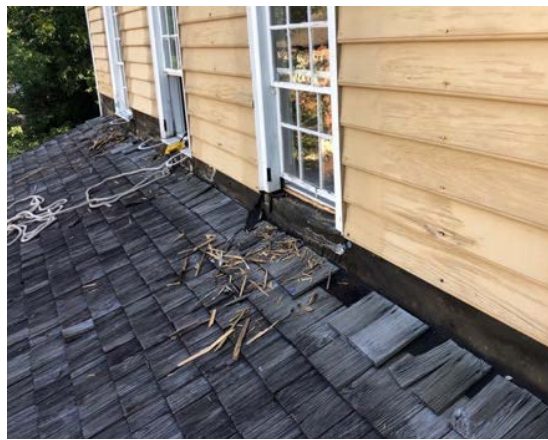
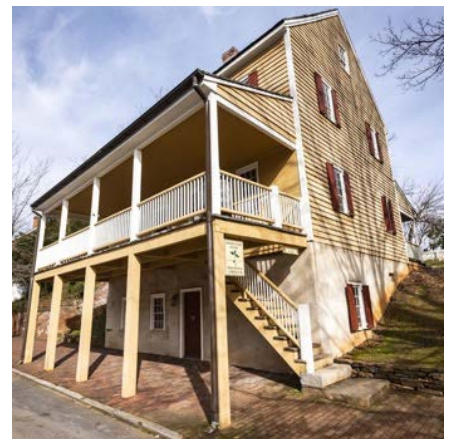
*(Left to right) The Herbst House restoration and repair has a long list of needs. The most urgent needs are found on the Main Street façade. Visitors use the porch and sidewalk stairs to access the new SEED SAVING LAB, so these repairs are essential to ensure a good quality experience. The windowsills, bottom clapboard, and roof shakes all needed full replacement before re-painting could occur.*

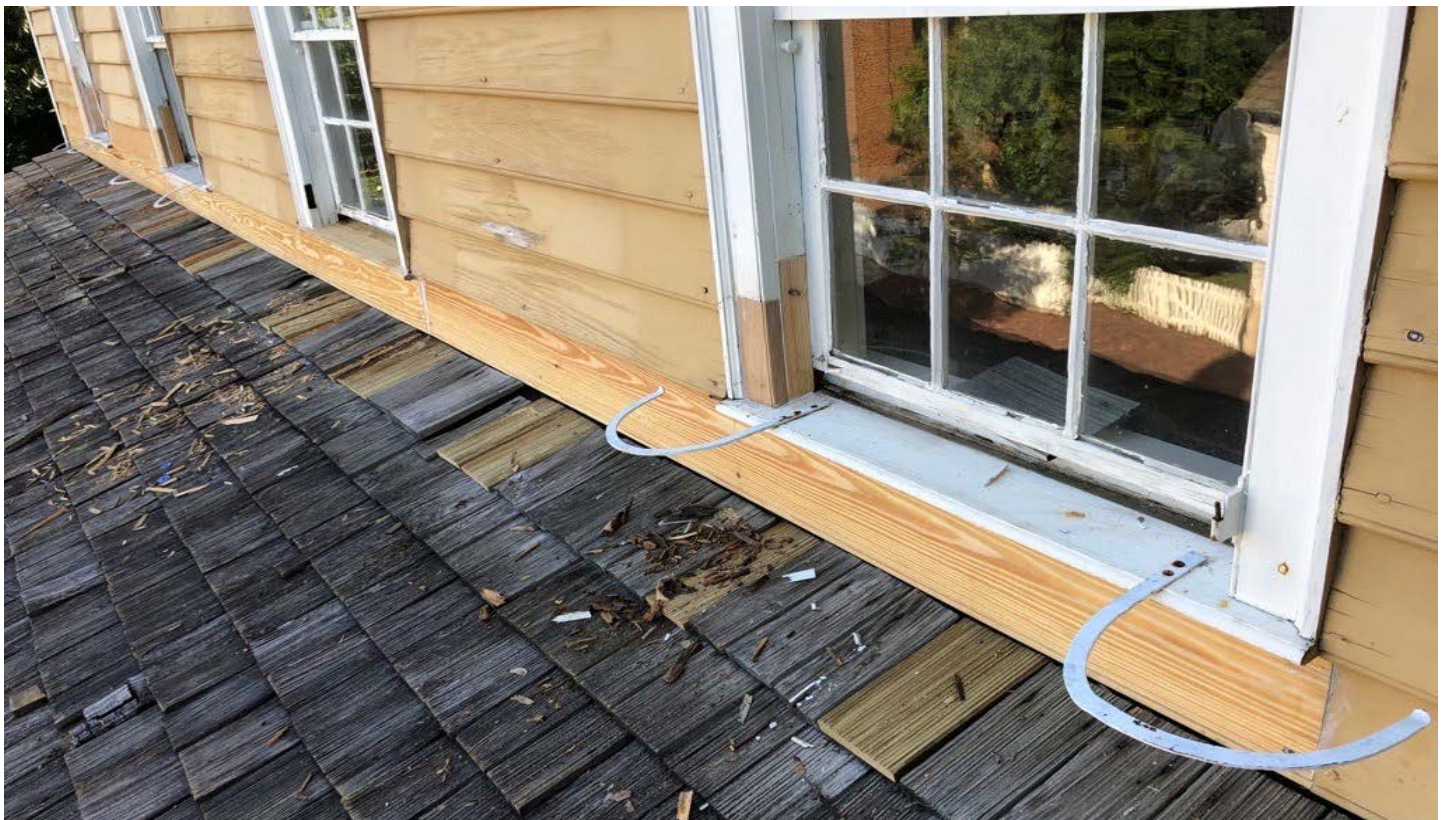
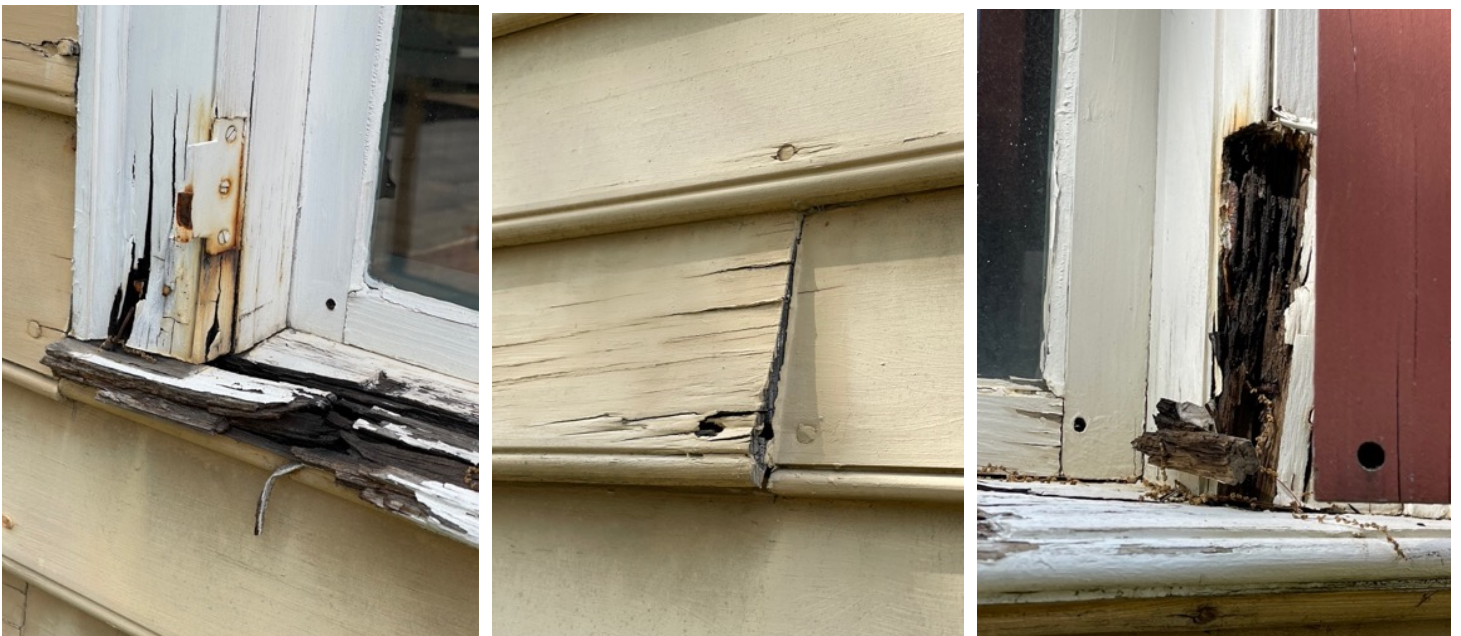
*(Left to right) The exterior wood sheathing and window frames needed some level of repair or replacement. The sills had become so rotten that the shutter hinges had fallen free from the screws and the shutters were poorly attached. As you can see from these photographs, the repairs needed to take place before any Fresh Coat Initiative painting could be done.*

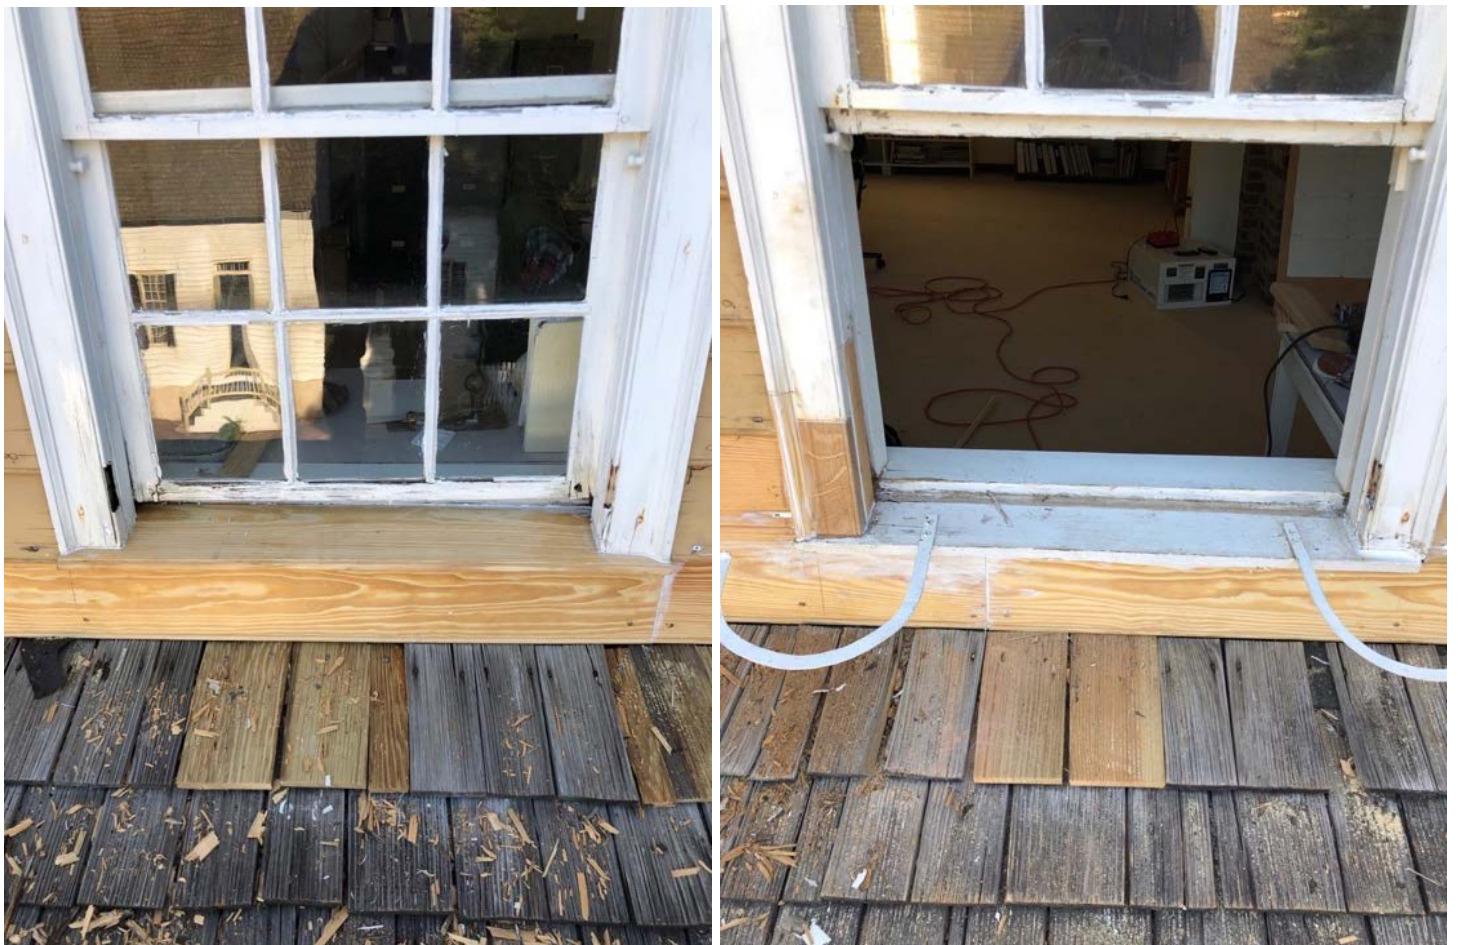
*(Left to right) Joiner Ben Masterson completed the expert repairs and restoration work with the logistical assistance of Erik Skarzynski, Director of Facilities. These types of restorations are like infill puzzle pieces carefully inserted into pre-existing building material.*

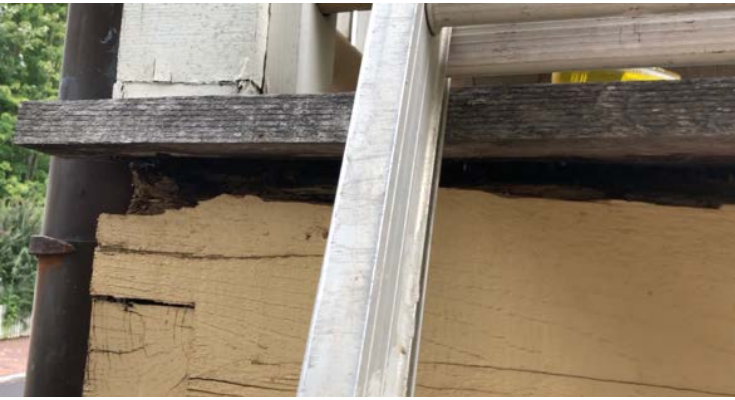
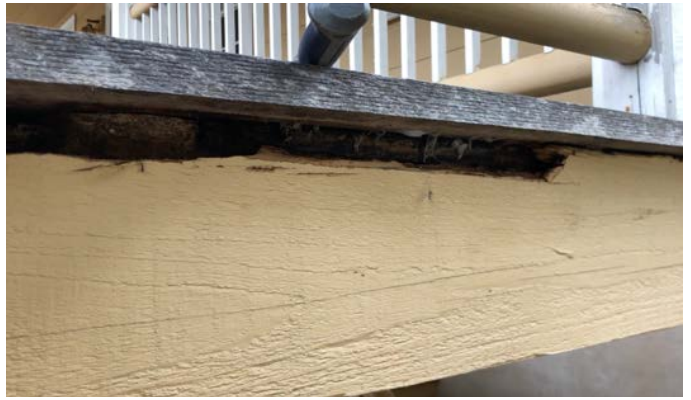
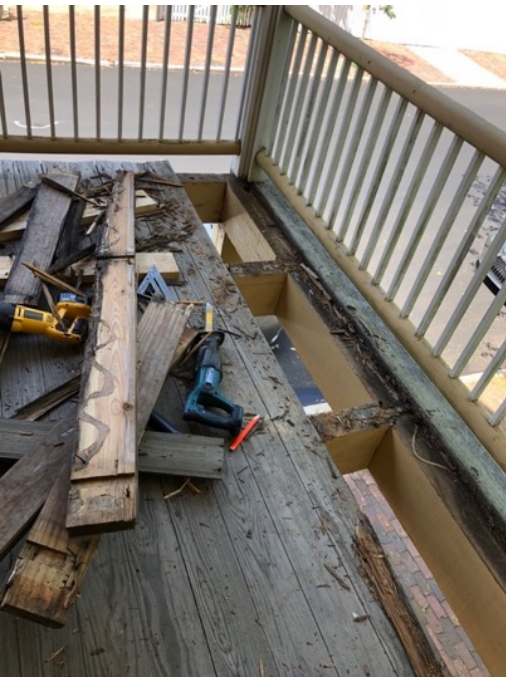
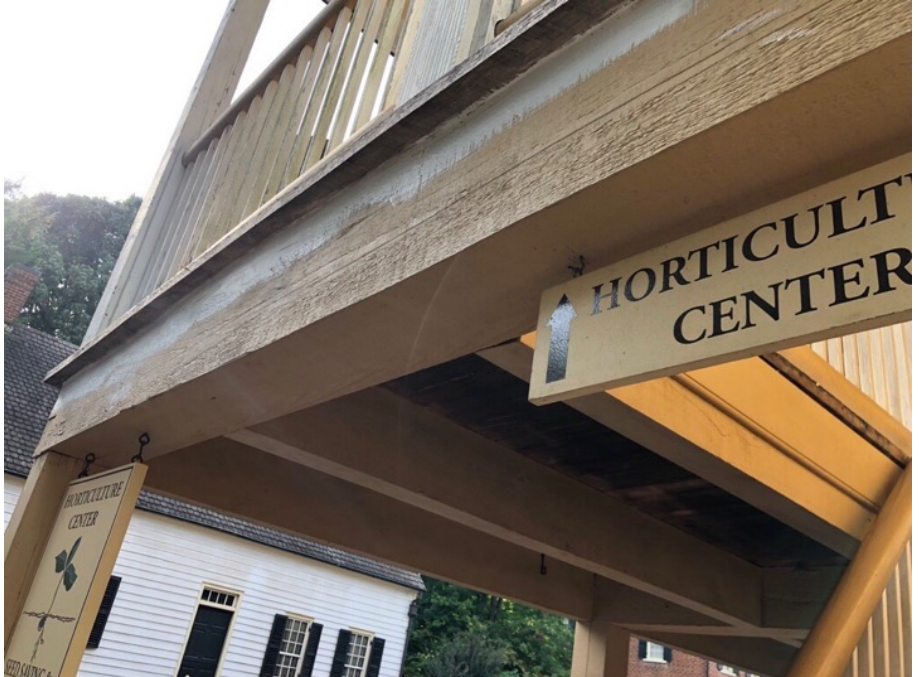
(TOP/BOTTOM - Left to right) The top row of photographs shows the extent of rot in the floor structure of the Main Street Porch. The floorboards were floating, unattached to the rotten beam below. The expert repairs and restoration work was completed by joiner **Ben Masterson** with the logistical assistance of **Erik Skarzynski, Director of Facilities**. The bottom row shows the removal of the floorboards which exposed the extent of the decay to the structure below. The finished repairs are blended in with the pre-existing building fabric and are awaiting repainting.

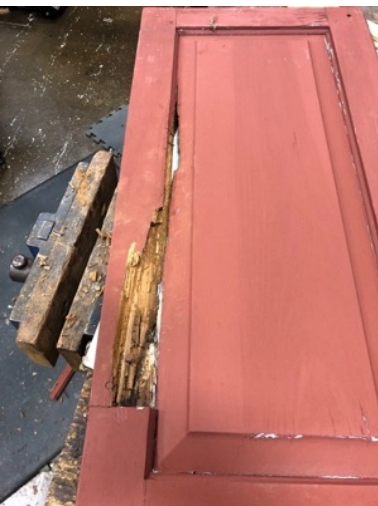
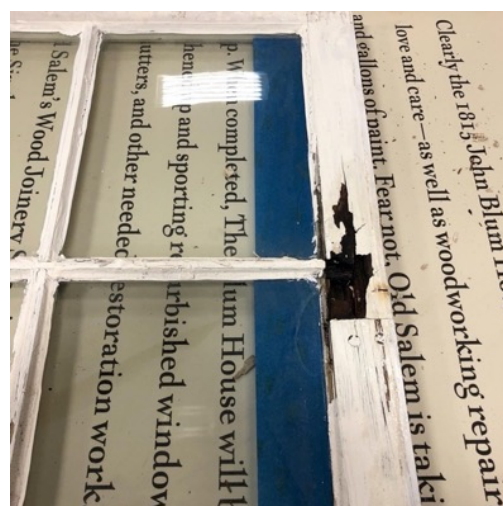
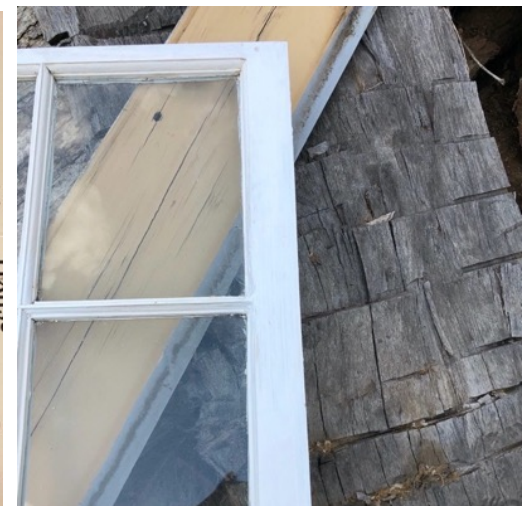
(left/right) Additional wood restoration work was needed on shutters and window sashes. The expert repairs and restoration work was completed by joiner **Ben Masterson** with the logistical assistance of **Erik Skarzynski, Director of Facilities**.
